Westview Tower Underside Roof Slab Concrete Repairs

By R. Curtis White Jr.

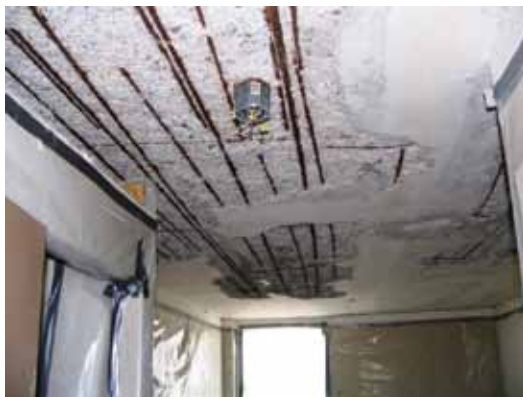
of the concrete was carbonated up to 2 in. (50.8 mm) deep, which had caused the lower layer of reinforcing steel to corrode and spall the concrete. Further inspection determined that this condition was isolated to the underside of the 13th floor roof slab but extended throughout the entire 10,000 ft² (929 m²) of the building footprint.

Fig. 2: Severe spalling of underside of roof slab

Once determination was made that concrete would have to be removed and replaced to a depth of 1.5 to 2 in. (38 to 51 mm) throughout the entire underside of the slab, attention turned to means and methods. All methods would require the relocation of the residents on the 13th floor and possibly two floors below that. In addition, complete removal of all partition walls would be necessary to provide access to the ceiling. Utilities and chases, however, had to be maintained so that the remainder of the building could continue to be occupied. Parts of the 12th floor would have to be evacuated to accommodate the shoring required to support the compromised roof slab during renovation. Additionally, under a form-and-pour scheme, parts of the 11th floor would also have to be cleared.

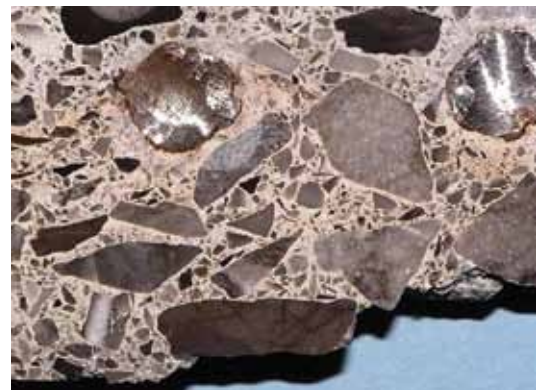
Fig. 3: Polished section of a concrete core illustrating corrosion in carbonated zone

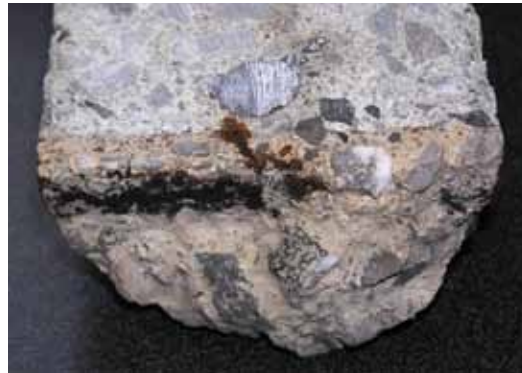
Fig. 4: Concrete core illustrating corrosion within carbonated zone

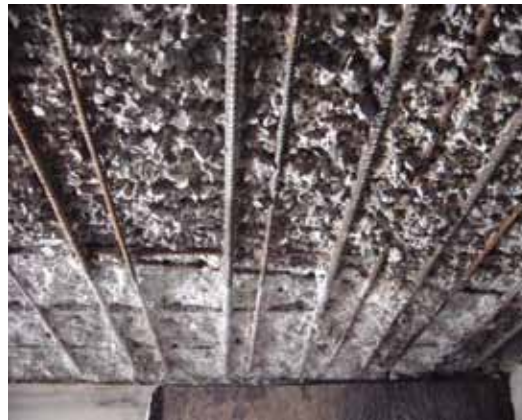
Fig. 5: Underside of roof slab illustrating difference between chipped area and hydrodemolition

Demolition was performed using hand-held pneumatic chipping hammers. Hydrodemolition was also used where possible. This presented its own challenges with capturing water above 11 floors of occupied space (remember all the utility penetrations?). In the end, it was more cost effective to continue the hand demolition. The extent of removal was verified by using a phenolphthalein solution on the chipped surface. Phenolphthalein is a pH indicator that turns bright purple on noncarbonated concrete. A purple color indicates the carbonated concrete had been effectively removed. After removal and confirmation with phenolphthalein, the reinforcing steel and concrete surface was blasted with abrasive, cleaned, rinsed with clean water, and left in a surface saturated dry (SSD) condition.

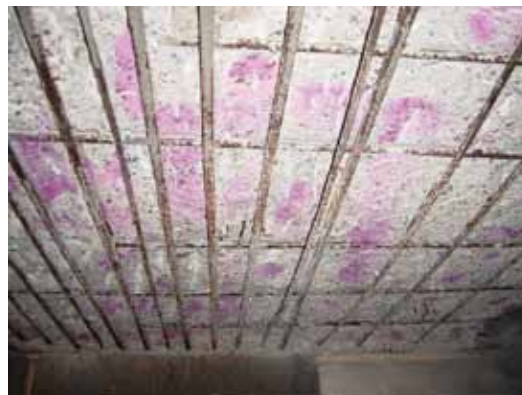
Fig. 6: Carbonated concrete removed and carbonation checked with phenolphthalein

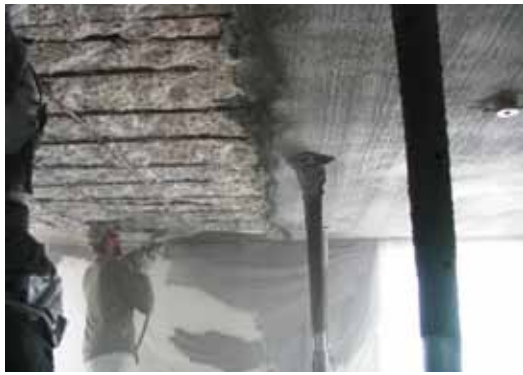
Fig. 7: Removal of existing concrete alongside completed shotcrete repair

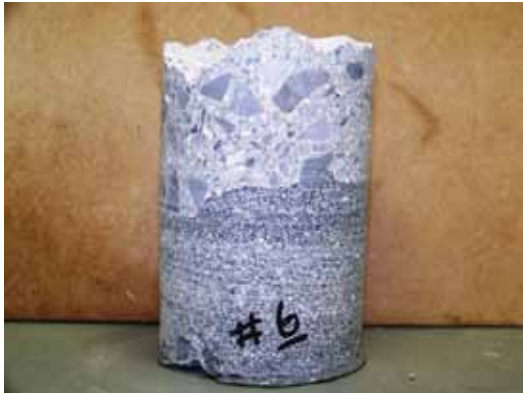
To ensure that a quality product was delivered by the contractor, bond testing was performed in accordance with ASTM C1583-04, "Standard Test Method for Tensile Strength of Concrete Surfaces and the Bond Strength or Tensile Strength of Concrete Repair and Overlay Materials by Direct Tension (Pull-Off Method)." Bond strengths ranged from 90 to 250 psi (0.9 to 1.7 MPa) with failure typically occurring in the parent concrete. Compressive strengths generally ranged from 3500 psi (24 MPa) in 3 days to

Fig. 8: Bond test core with failure within the substrate concrete

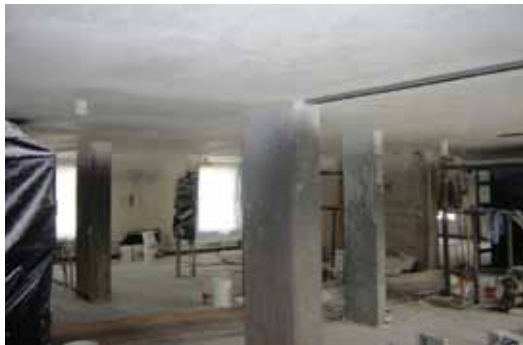
Fig. 9: Completed repair

mark the grades and the shotcrete was hand-trimmed to those marks. Finally, a light flash coat was applied to hide any trowel marks and the entire ceiling was given a textured paint coat for the final exposed ceiling.
