# Outstanding Shotcrete Project Award Winner

## 2005 Outstanding Underground Project:

# The Center for National Response

by Henry A. Russell, Jr.

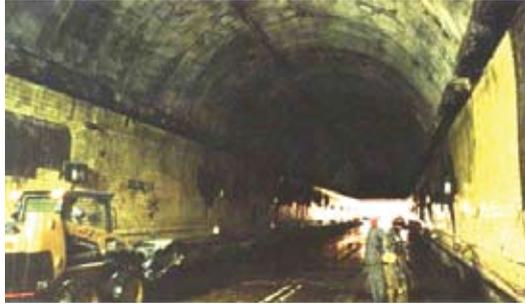
*Typical tunnel cross section*

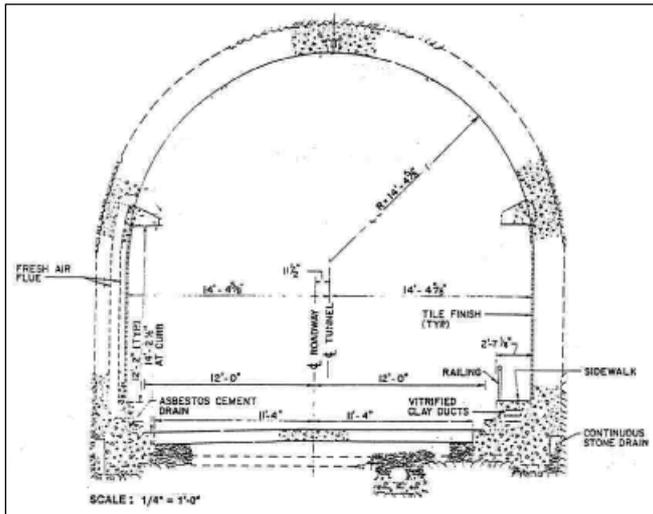
*Typical existing tunnel section*

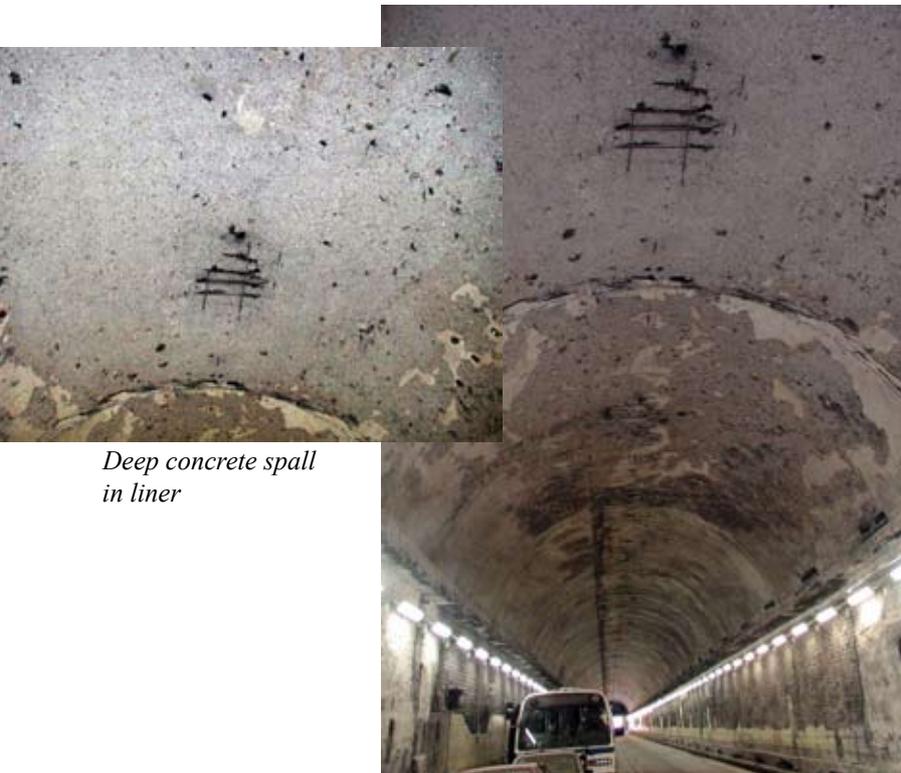
*Deep concrete spall in liner*

*Typical structural damage from fire tests*

During the test program, a fire pot was installed in the tunnel, affecting approximately 400 linear ft (122 m) of tunnel arch that has severe spalling and delamination due to the intense heat of the tests. In these areas, the tunnel arch has undergone severe stress as a result of the thermal activity, and the ultimate strength of the concrete is in question. The loss of cross section of concrete in the arch places unusual load on bedrock, which is one of the areas that required additional support during construction. The reinforcement that was exposed has not buckled or failed. This spalling has occurred in two distinct areas and must be repaired to maintain the long-term structural integrity of the tunnel. The best method to reinstate the tunnel lining in the arch is to apply wet-process shotcrete using fibers to provide additional strength. New reinforcing steel is also required and, in combination, will provide for a suitable long-term monolithic repair.

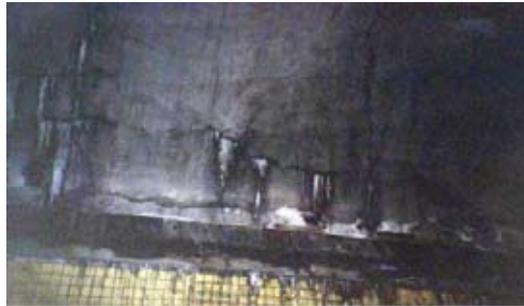
The tunnel arch for the entire length of the tunnel is subject to groundwater intrusion at numerous construction joints and cracks and at the interface of the portal building and the tunnel headwalls. As a result of the intense heat from the fire tests, the construction joints have, in most cases, lost their ability to seal the joint. It appears that the bitumen used for the waterproofing has melted out of the joint or was incinerated. In many cases, the leaking concrete cracks are random in nature and are either a result of concrete shrinkage, settlement or movement, or thermal movement during the fire test program. These leaking construction joints and open leaking cracks must

Typical leaking crack in tunnel arch

The sealing of leaking concrete cracks and construction joints was to prevent the infiltration of groundwater and may be performed by the injection of chemical grout. Chemical grout is the preferred product to seal leaking concrete cracks. The injection of chemical grout into the leaking crack is performed by a single-component water-reactive polyurethane chemical grout. The installation is performed by the drilling of angle holes into the repair area at a high angle to intersect the crack at the midpoint of the wall. Injection ports are installed and the ports are flushed with fresh water. This flushing removes any laitance in the crack and provides a catalyst to react the chemical grout. The injection of the polyurethane grout is performed working from one end of the crack to the other, observing the return of the grout on the concrete surface. This process provides full-depth penetration of the cracks, is flexible, and has the ability to move with the crack as a result of thermal expansion.

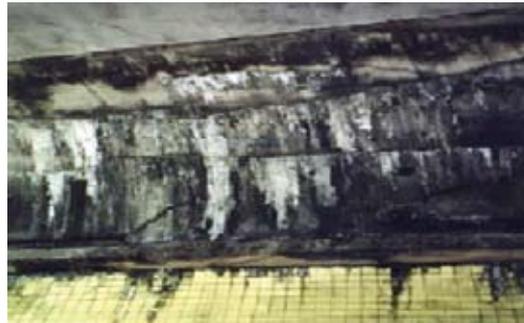
At Station 14+50 northerly for a distance of 180 ft (55 m) on the west side of the tunnel arch, there exists a series of parallel longitudinal cracks that parallel the centerline of the tunnel. The presence of close parallel horizontal cracks at an orientation parallel to the centerline of the tunnel arch create a potential for the tunnel to have part of the liner fall into the tunnel and cause a failure of the arch. These cracks present a stability problem for the arch and must be sealed and reinforced with a structural overlay of a fiber-reinforced cementitious mortar to reinstate the stability of the arch.

Station 14+50—horizontal cracking of arch

The concrete arch cracking required the structural integrity of the arch to be restored. This required placing a series of reinforced shotcrete bands on the interior of the tunnel liner form springline to springline of the arch to transfer the compression load of the arch to the vertical walls of the tunnel.

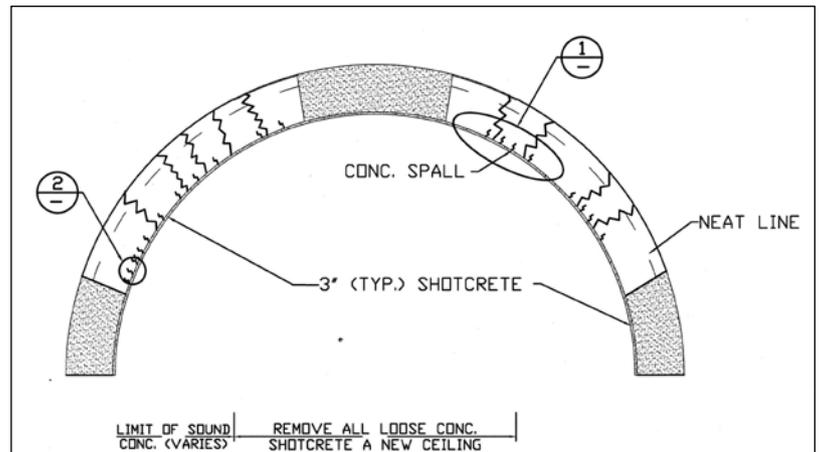
Typical tunnel liner shotcrete bands

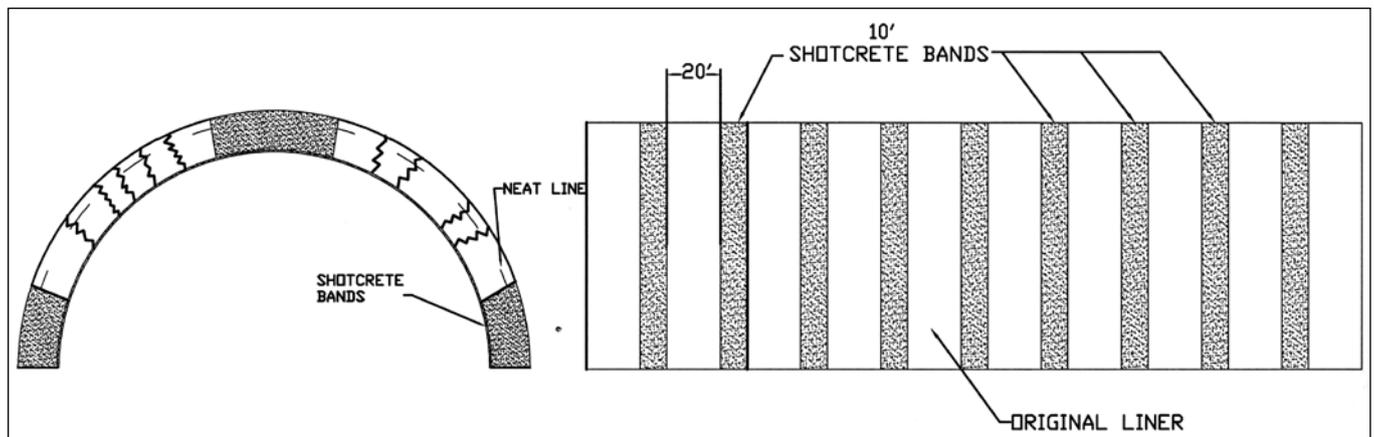
Layout of tunnel liner shotcrete bands

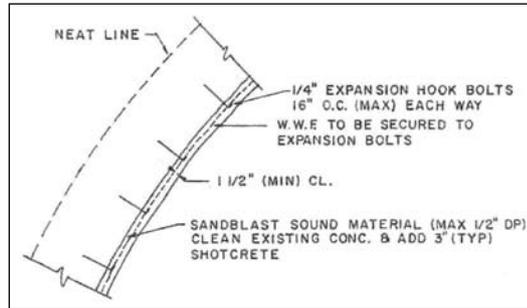
*Detail for concrete arch repair*

is a process of applying prepackaged fiber-reinforced fly-ash-modified mortar by pneumatic means. The material, prepackaged by the manufacturer to ensure proper proportions and quality control, is moistened on site and applied by a dry-process shotcrete method. The areas to be repaired are prepared by power washing to remove any laitance, and a wire mesh is mechanically attached to the substrate prior to the application of the shotcrete. Any leaking concrete cracks or construction joints must be sealed prior to the application of the shotcrete; otherwise, the shotcrete will not bond properly to the substrate.

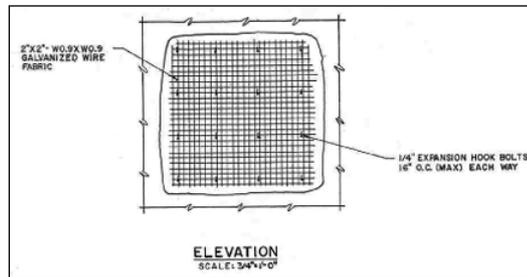
*Typical shotcrete repairs*

The application of this shrinkage-compensated fiber-reinforced material provided a durable, sound monolithic repair. The application was chosen due to the project time restraints, as the process is rapid with minimal overspray or rebound, resulting in minimal cleanup.

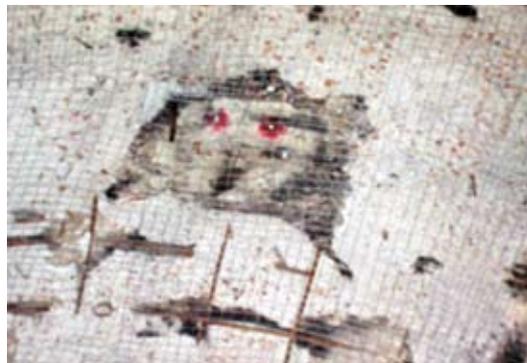
*Typical spalled area for repair with welded wire installed*

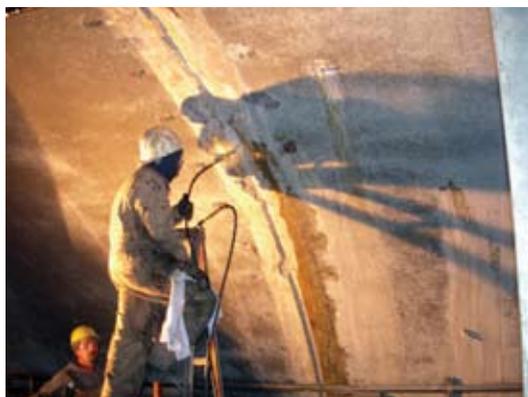
*Typical chemical grout injection for tunnel joints*

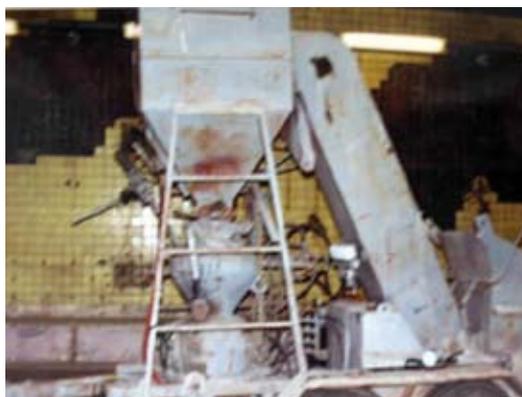
*Dry-process shotcrete machine with premoistener*

The shotcrete was applied using a standard dry-process shotcrete machine with a premoistener to minimize dust. The work was generally performed from a man lift with the shotcrete machine on the roadway. The prepackaged shotcrete was delivered in super sacks to facilitate production.
