Pineda Causeway Bridge Rehabilitation

By R. Curtis White Jr.

Pineda Causeway Bridge, State Route 404 over the Indian River (Atlantic Intracoastal Waterway)

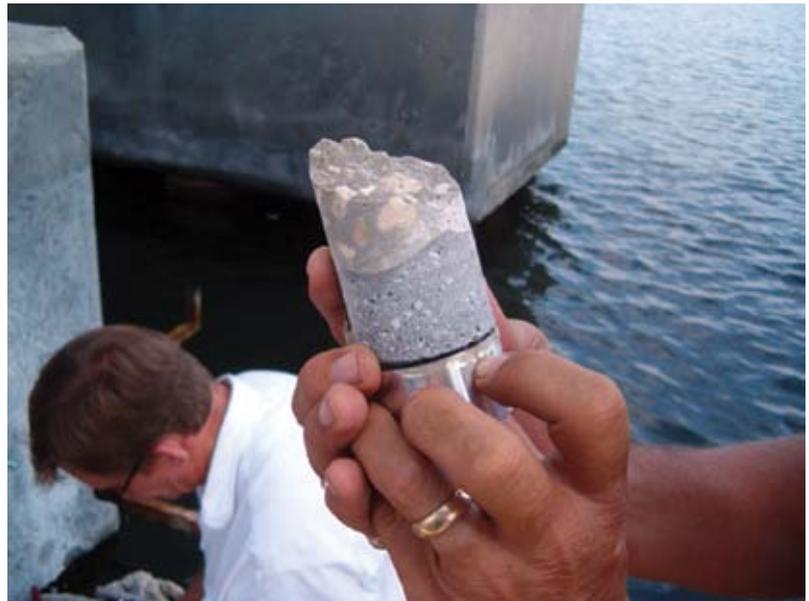
Pullout test showing core failure in substrate

To prove the effectiveness of the shotcrete repairs, FDOT required random bond strength tests. These tests were accomplished using ASTM C1583/1583M-04e1, “Standard Test Method for Tensile Strength of Concrete Surfaces and the Bond Strength or Tensile Strength of Concrete Repair and Overlay Materials by Direct Tension (Pull-off Method).” Pull-off tests of repairs on the footings resulted in failure in the old concrete substrate—generally at values above 200 psi (1 MPa). Any failure in the parent concrete is an indication of the successful bonding between the substrate and the repair material.

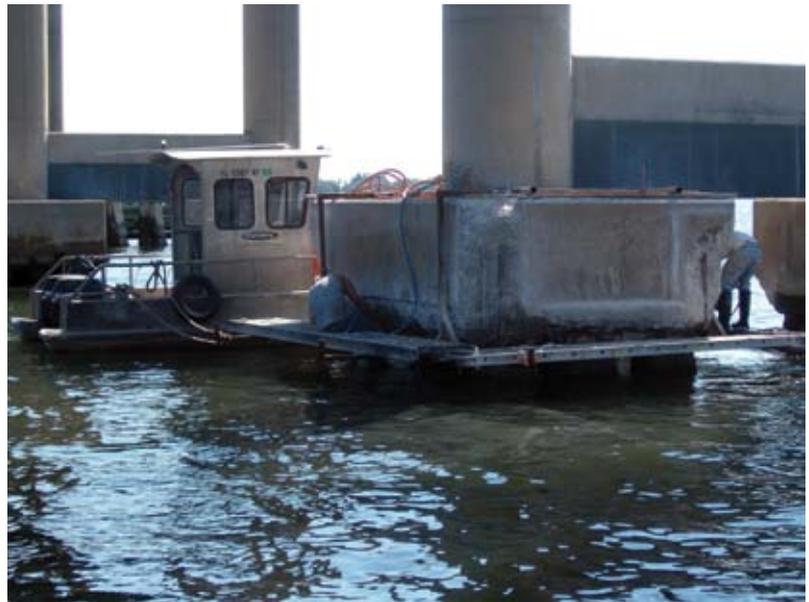
Removal of spalled concrete from pile caps

The bridge had experienced significant spalling and delamination of concrete at the waterline of the low-level pile caps since its construction in 1969. An earlier repair of the spalling was attempted using form-and-pump methods. It was a particularly difficult forming job because the piles were not positioned the same on any of the 84 lower pile caps being repaired. This meant that there was no repeatability in forming the repair, so all the forms were custom-built. In addition, the forms needed to be supported under the caps with no clearance from the water—except at low-tide water level—and then only 8 in. (203 mm) could be anticipated. So, in essence, the plan was to support the 84 custom-built forms with skyhooks and hope the repair concrete bonded upside down. This was not a recipe for success.

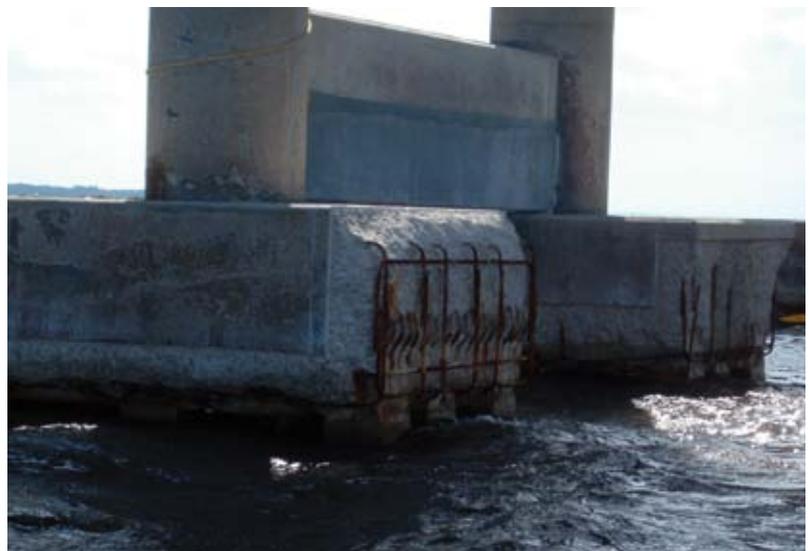
Pile caps after chipping and ready for shotcreting

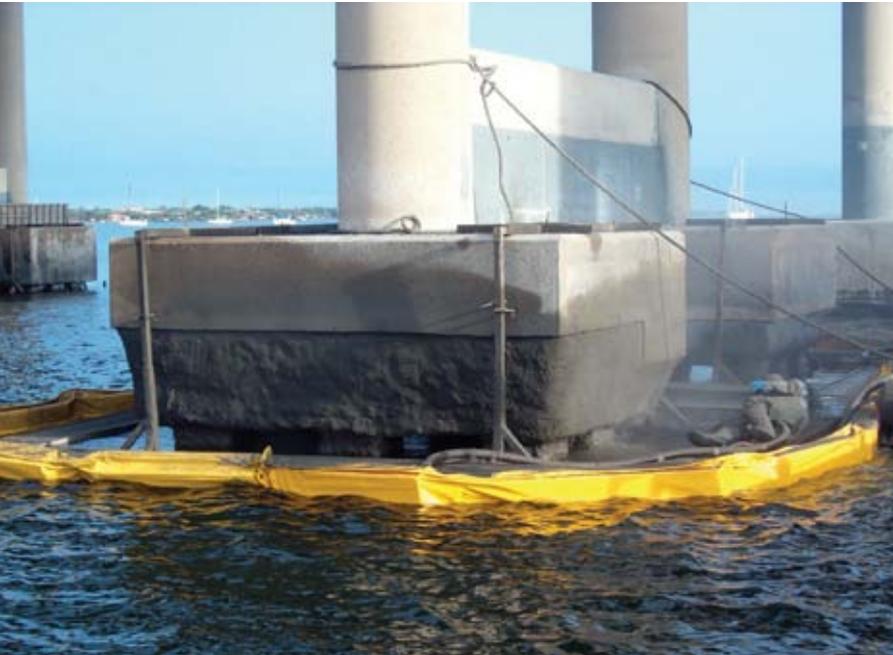
Shotcrete placement on low water pile caps

The successful bidder was 25% lower than the second bid. The low bidder suggested a value engineering change to the procedure from the beginning. His proposal was to change only the method of placement from form-and-pump to dry-mix shotcrete. Dry-mix shotcrete was proposed because of the access restrictions that required all work be done from watercraft with no highway traffic lane closures allowed. The relatively small quantities and long travel distance from the staging area to the work site precluded the efficient use of wet-mix shotcrete.

The repair material placed on this project was Gunitite 7001d, a single-component, modified silica-fume shotcrete material with 1/2 in. (13 mm) polypropylene fibers produced by U.S. Concrete Products of Baltimore, MD. Twenty-eight-day compressive strength test results were in excess of 7000 psi (48 MPa). These tests were conducted in accordance with ASTM C1140-03a, “Standard Practice for Preparing and Testing Specimens from Shotcrete Test Panels” and performed on cores taken from test panels made in

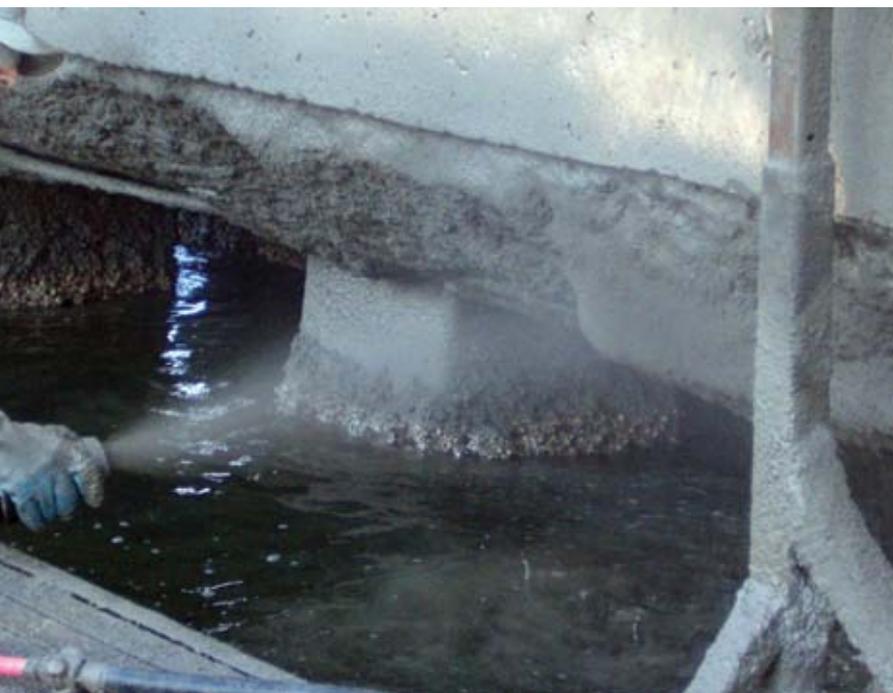
Dry-mix shotcrete can be placed slowly to reduce fallouts

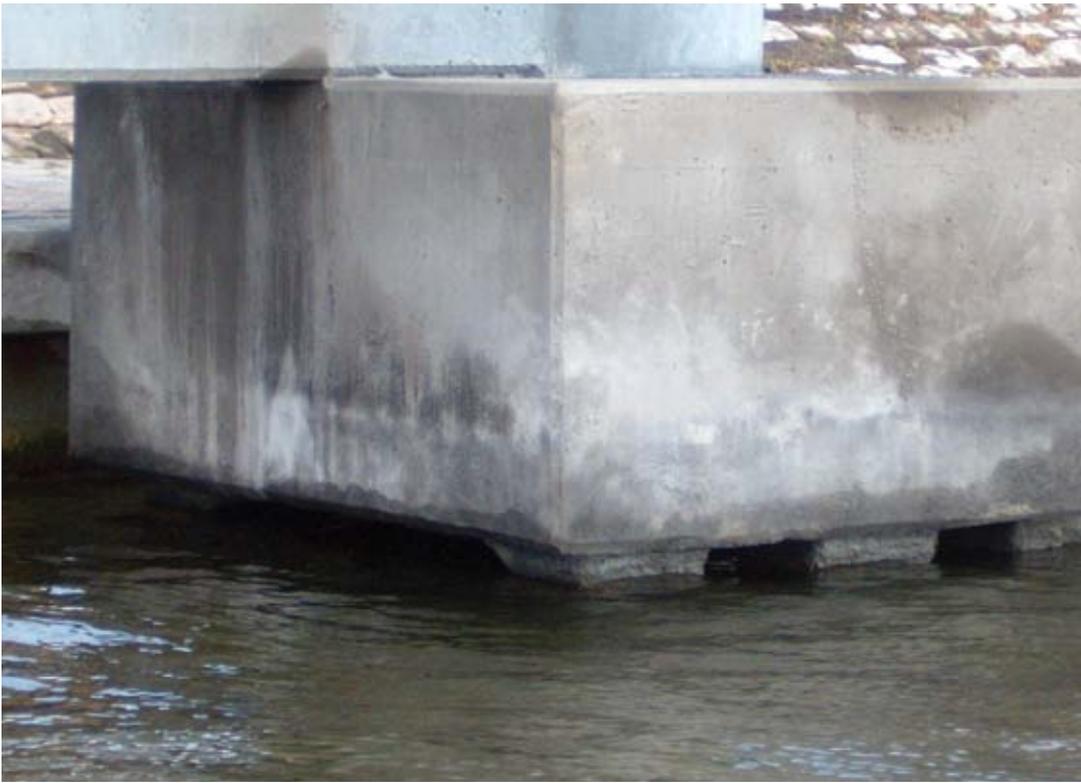
Close-up of reinstalled chamfers

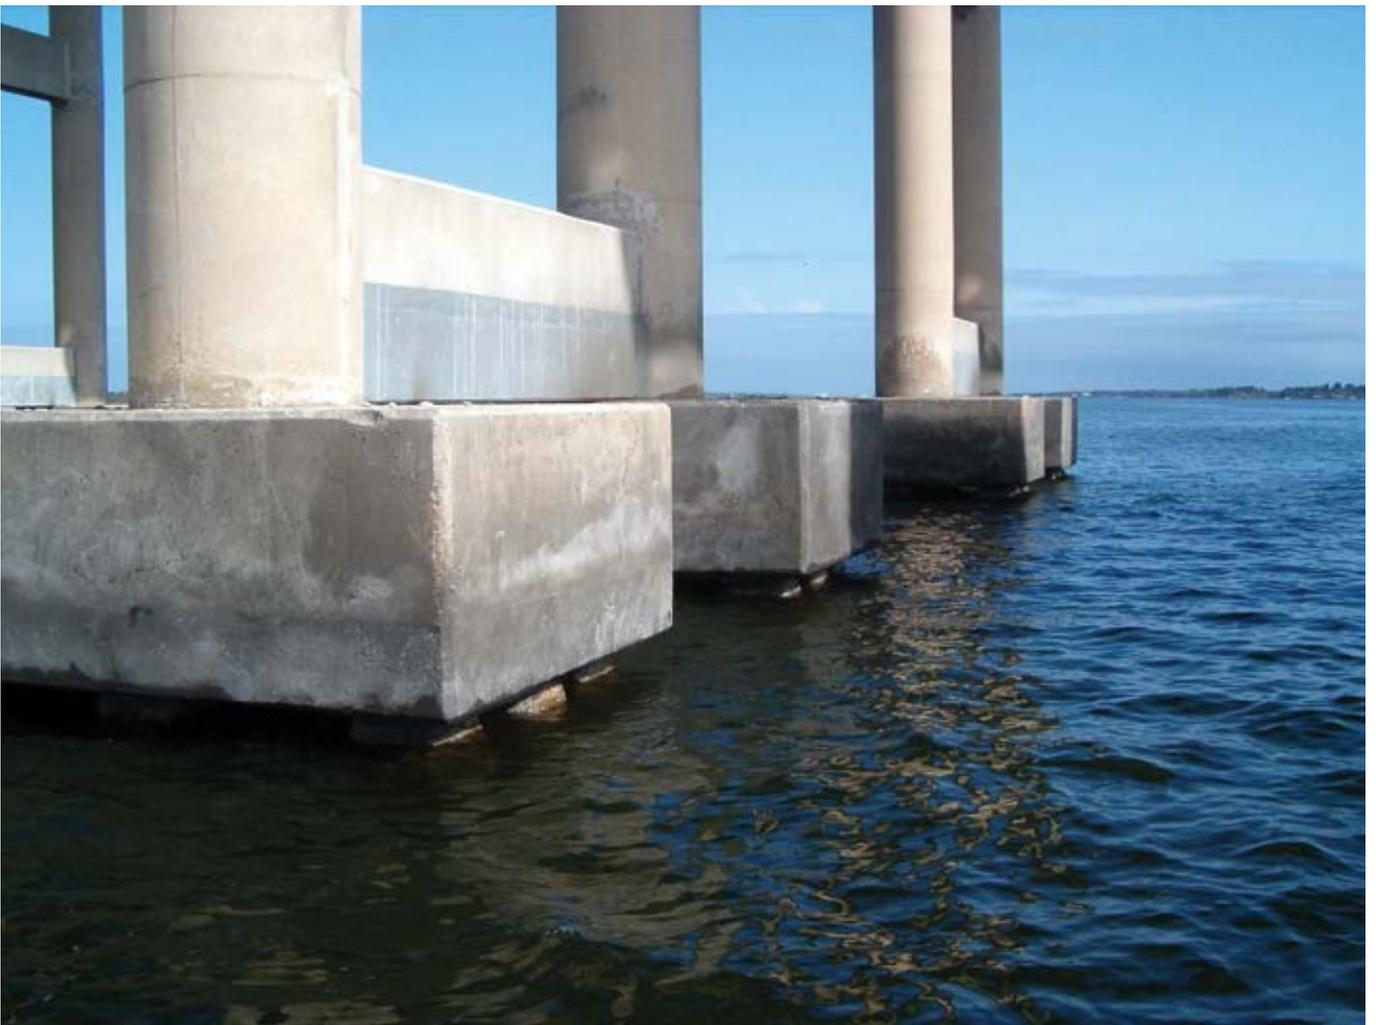
Completed low water pile caps
